Proceedings of the

10th CANADIAN
ROCK MECHANICS
SYMPOSIUM

KINGSTON, SEPTEMBER 2-4, 1975

GROUND CONTROL IN TRANSVERSE CUT AND FILL MINING OPERATIONS AT INCO

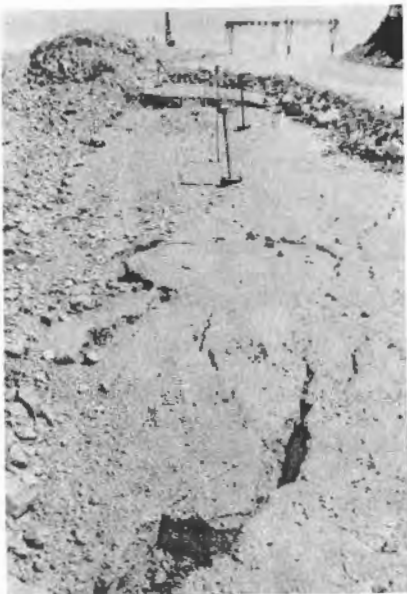
FIGURE 11
SOUTH WALL
HAUL ROAD

The south wall area is shown in Figure 11. Stabilization of the area was not carried out, as the cost and time spent was not warranted. The haul road will not be used after Pit (1) is completed this year (1975). Further it would be possible to reroute traffic through Pit 3.

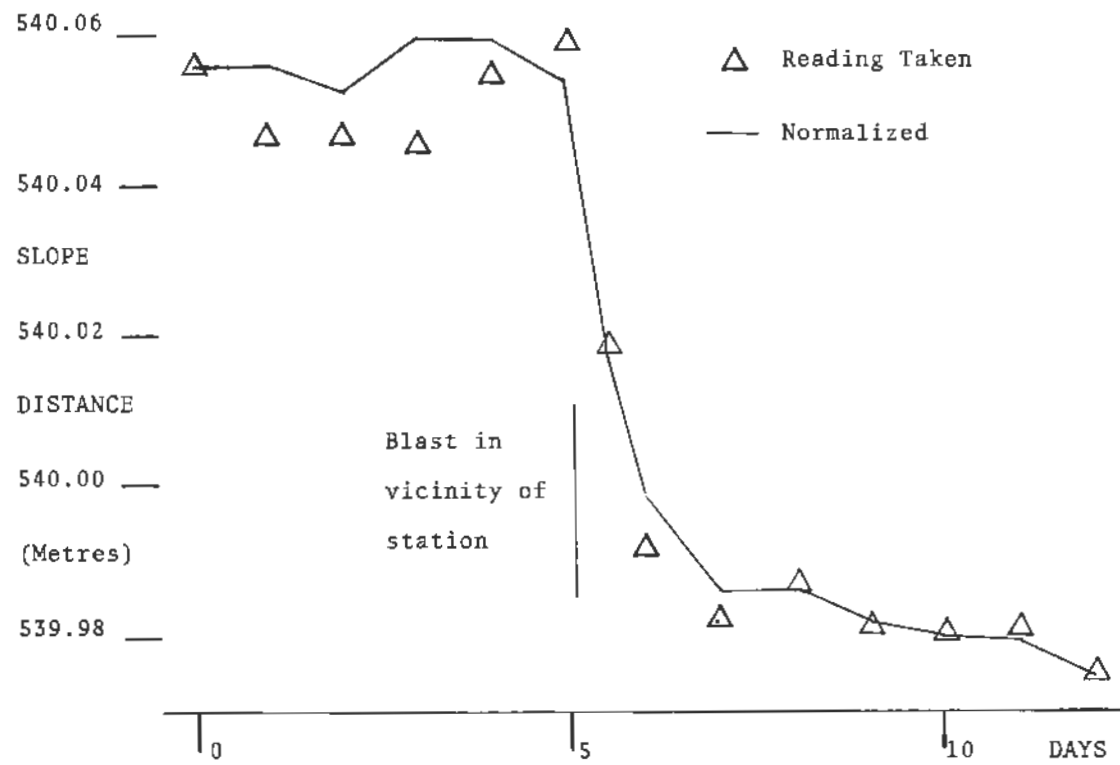
FIGURE 8

SLOPE DISTANCE NORMALIZED TO BACKSIGHT

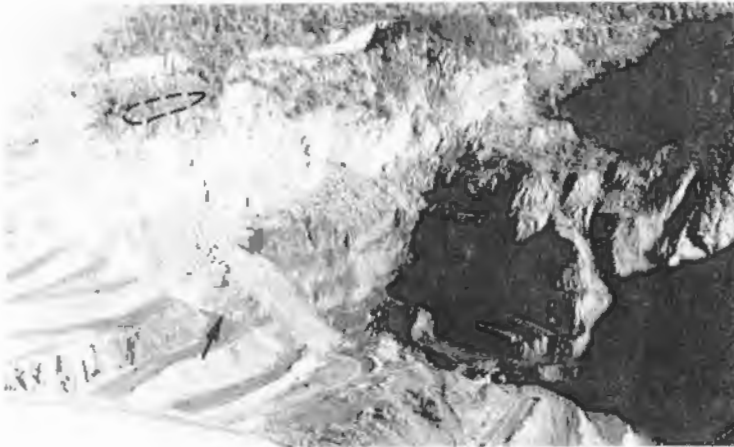
FIGURE 2 AERIAL PHOTOGRAPH OF HOGARTH NO.1 ZONE HIGHWALL -
SEPTEMBER 1974
(The location of the main cracks is indicated.
The arrow shows the site of the guard shack.)
